**Jupiter Reef Club  
Jupiter, FL**

**Seawall Conditions Assessment Report**  
February 27, 2015

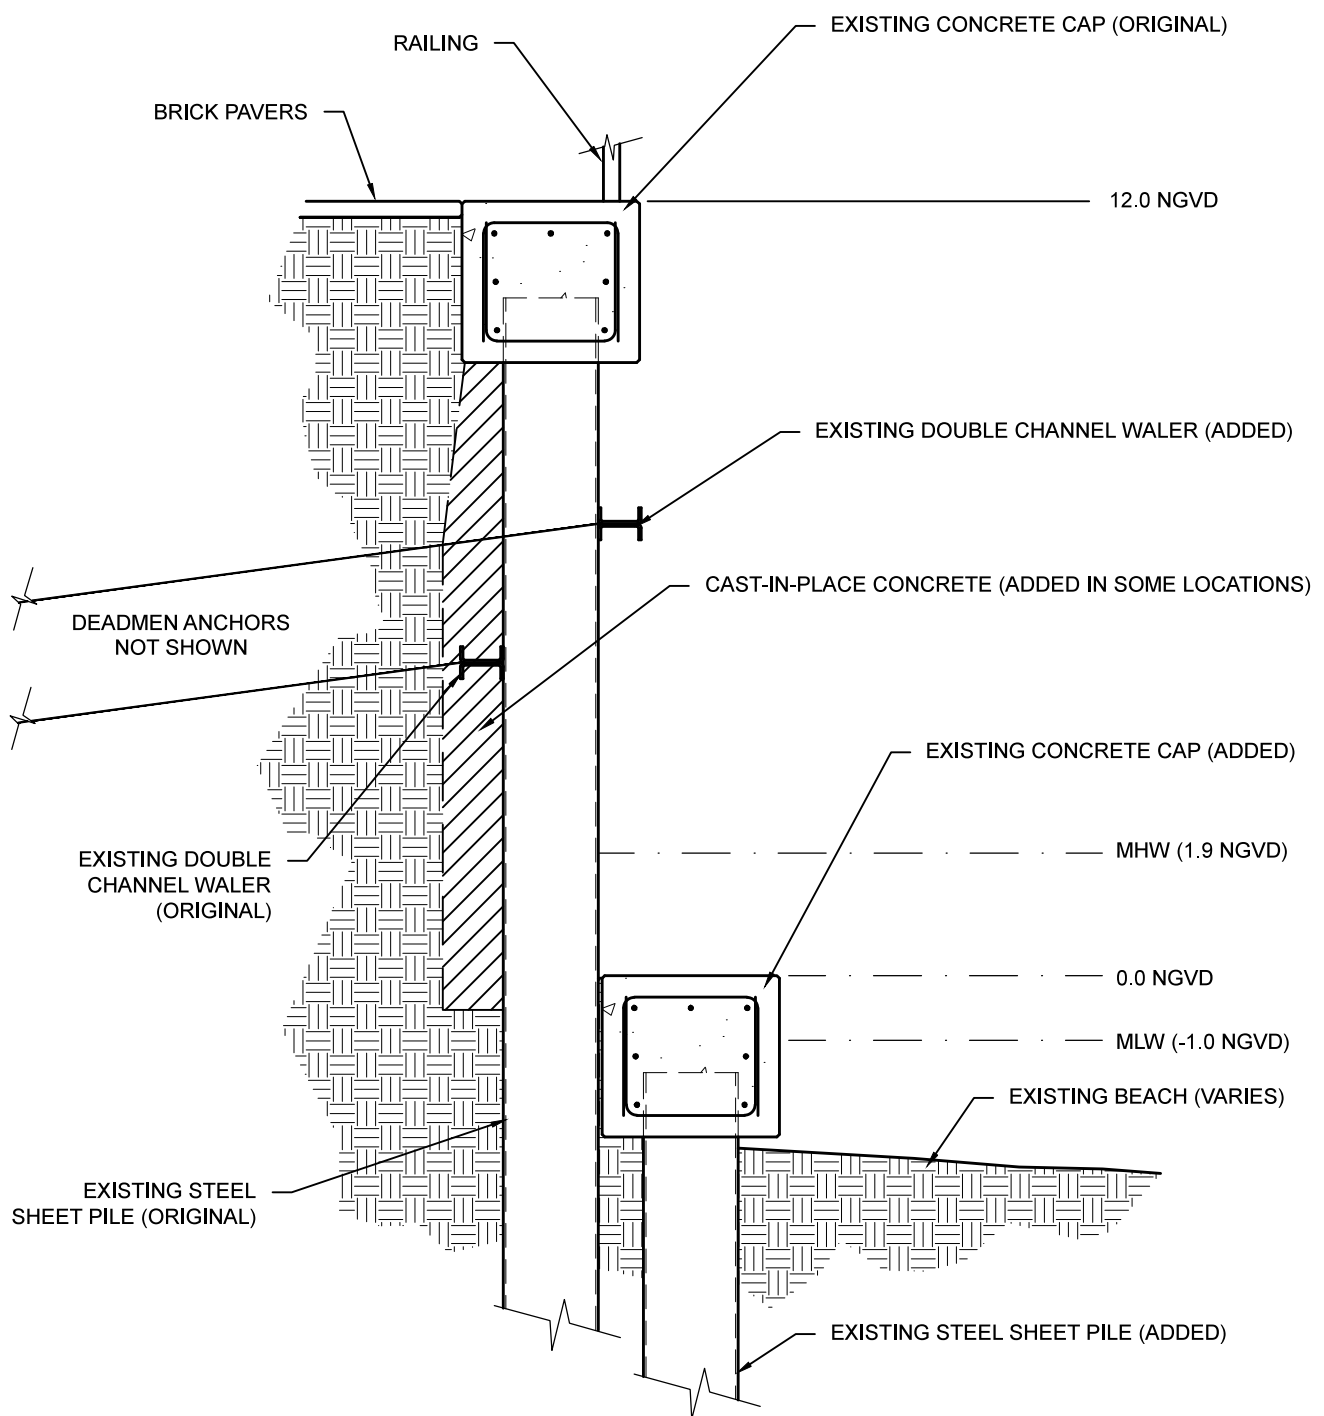
FIGURE 1  
EXISTING CONDITIONS  
JUPITER REEF CLUB SEAWALL

The existing Jupiter Reef Club seawall consists of an original steel sheetpile seawall and multiple additions and repairs accomplished over the years. Figure 1 shows a typical schematic cross section of the existing conditions, outlined as follows:

- **Original steel sheetpile wall:** the original seawall consists of steel sheetpile, a tieback system attached to a waler on the backside of the sheeting, and a concrete cap. No drawings or details on this original wall are available; its installation date is estimated at the mid-1950's based on anecdotal evidence and the sheetpile type.

- **Secondary toewall:** a secondary toewall was added at some point, consisting of steel sheetpile installed along the lower waterside face of the original seawall, with a large concrete cap. No drawings or details on this toewall are available, but it was installed sometime between the mid-50's and late 70's, as it is clearly evident in multiple photographs from the early 80's.

- **Concrete facing on original sheetpile wall:** in 1982, during installation of the parking lot wings, the original steel seawall was covered with a protective layer of concrete, likely sprayed on (commonly known as shotcrete or gunite). The old steel groins were also

encased in concrete at this time, at their intersection with the seawall. Plans and photographs were found briefly outlining this project, which was accomplished by Murphy Construction.

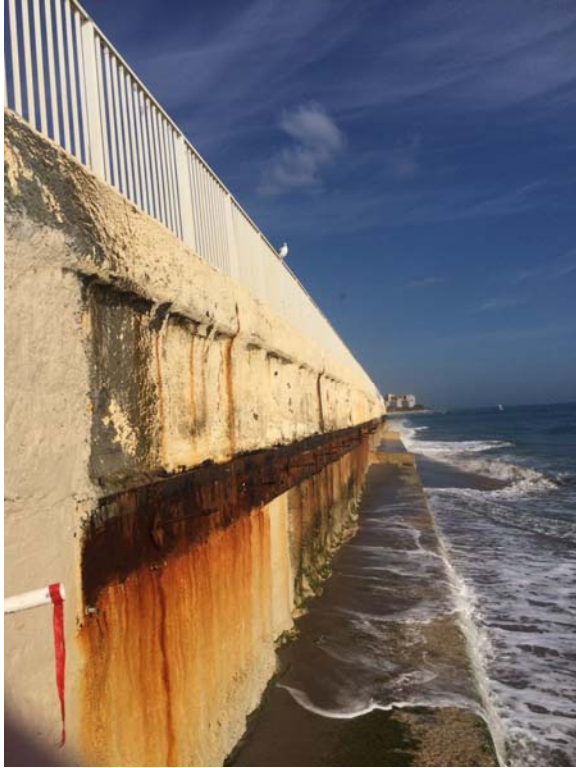
Existing elevation at inspection time:

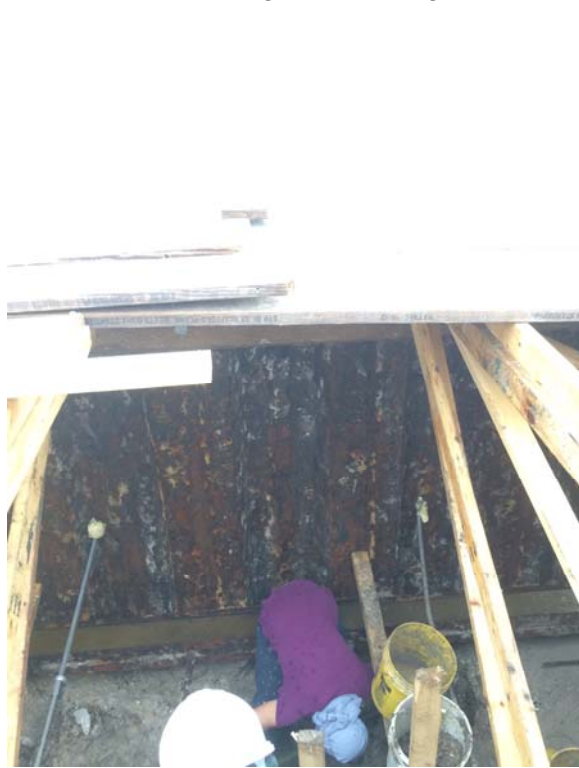
- **Original steel sheetpile wall:** the original steel sheeting is in an advanced state of deterioration. While the waterside face is not visible due to the 1982 concrete facing, the sheeting was visible from the backside during the recent repair work. Significant steel corrosion and loss of cross section is evident, with the concrete facing being visible from the backside in some areas, indicating a complete loss of the steel sheeting. Significant rust-staining and delamination of the concrete facing also indicates advanced steel sheeting corrosion. During the recent southeast corner repair, visible holes were discovered, where both the sheeting and concrete facing were completely gone.
- **Secondary toewall:** the toewall steel sheeting was exposed in varying degrees, from 6" to 24" vertically. Significant corrosion of the toewall sheeting is evident, with holes

Backside view of original sheeting:

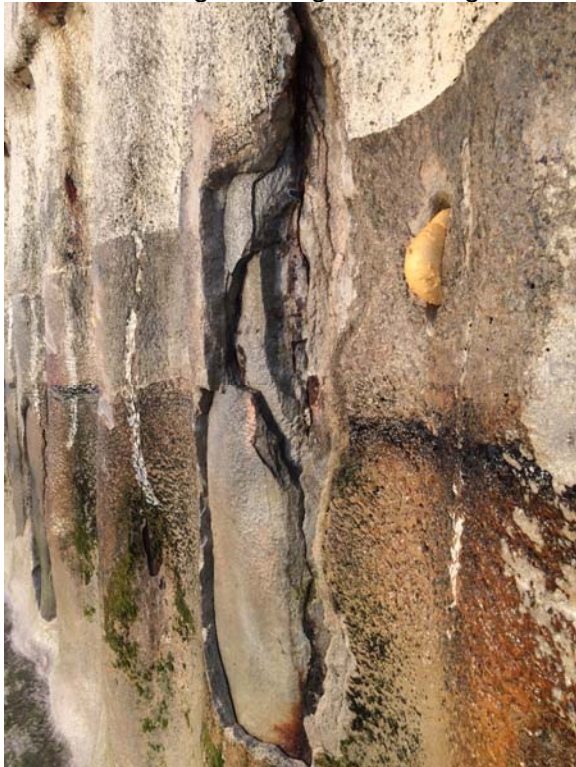
- **Concrete facing on original sheetpile wall:** the concrete facing is cracking and spalling (delaminating from the steel sheeting due to excessive rusting and expansion of the steel). In some areas, large sections of concrete have fallen off, exposing additional concrete beneath (possibly a second layer of the concrete facing). The intense wave action against the steel walers and tierods is causing cracking and wallowing of holes through the concrete facing and original steel sheeting. These holes are allowing a loss of backfill behind the wall (some of these tierod holes currently being temporarily sealed and patched).

Concrete facing cracking and rusting:

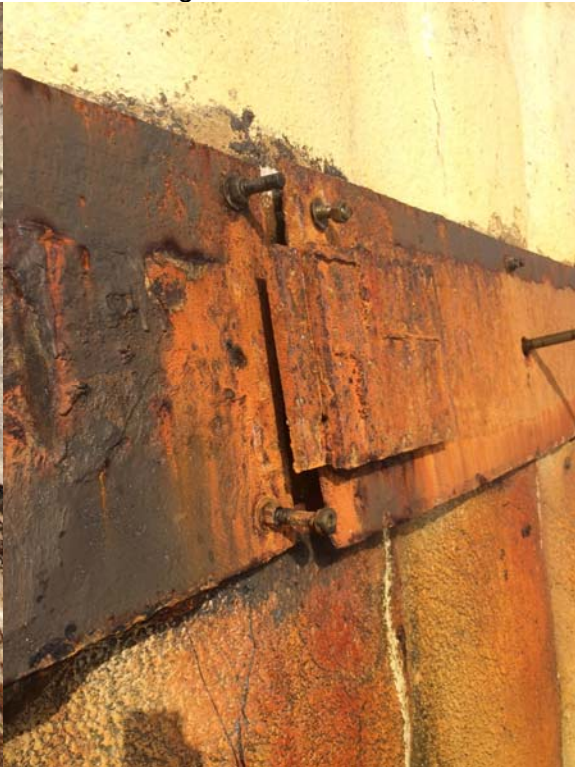
- **Waterside steel walers and tiebacks:** The steel walers and tierods are in varying states of failure, with beams bowing and falling off, tierods missing nuts and washers, and tierods corroding and rusting. As mentioned above, the current loose condition of the waler beams is exacerbating the damage to the concrete facing and original steel sheeting, through constant vibrations and movements under the wind and wave loads.

Severe rusting of waler; loss of nuts, washers:

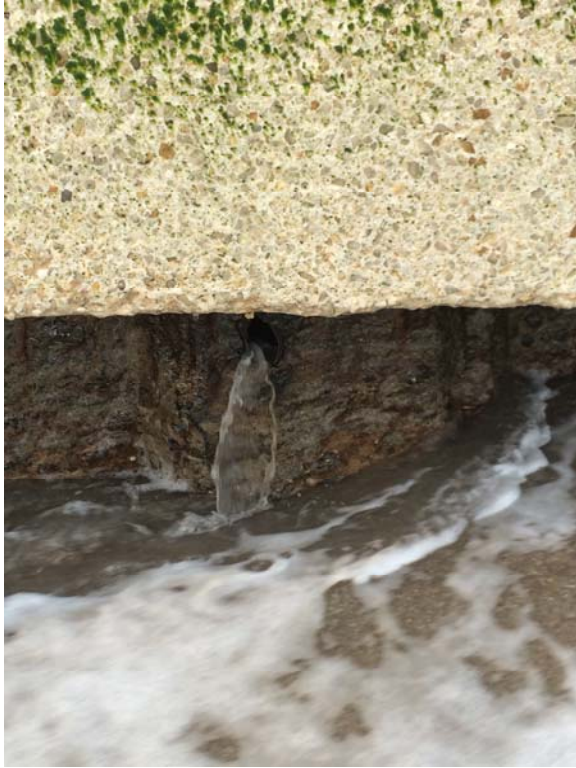
Hole in toewall sheeting, small, leaking:

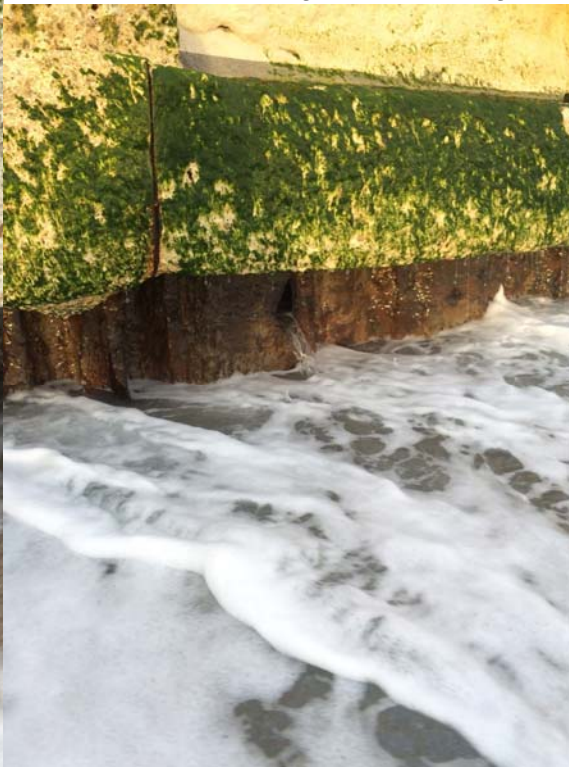
Hole in toewall sheeting, small, leaking:

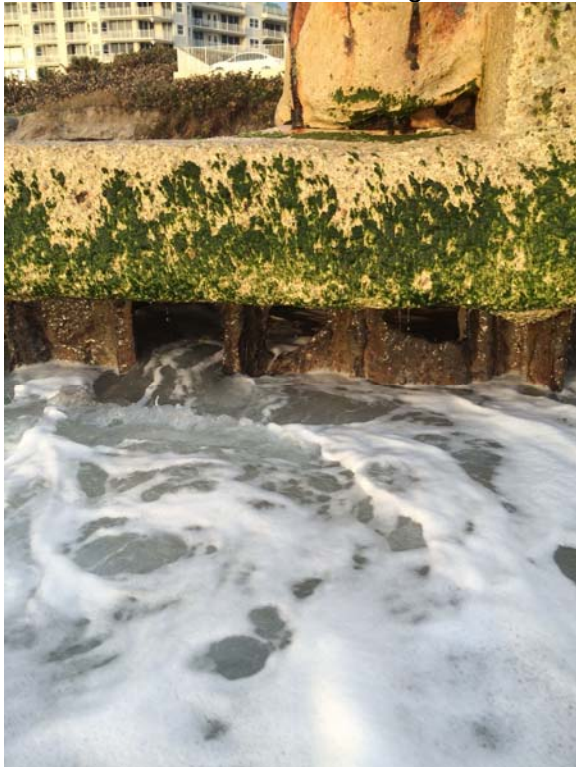
Deterioration of toewall sheeting:

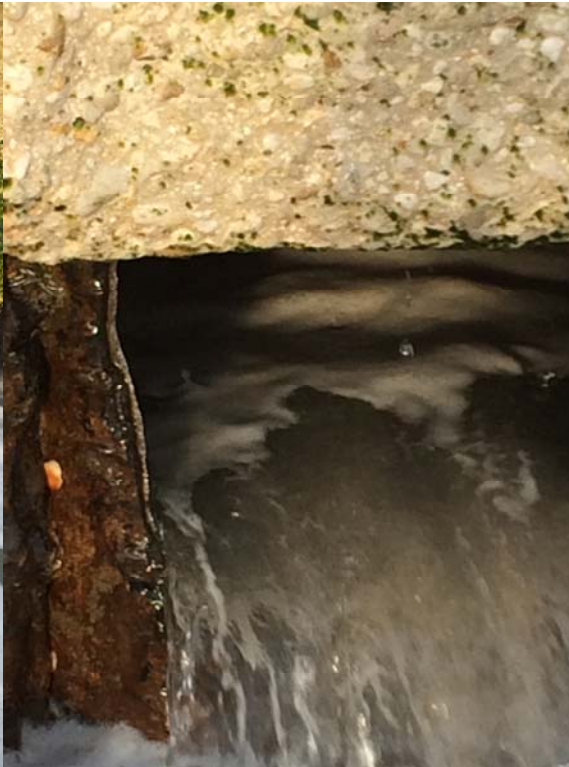
developing through the sheeting, in some cases very large. While the toewall undergoes a constant cycle of being covered with sand and then exposed, at the current time it is exposed and backfill is leaking out at an alarming rate. This is particularly the case at the northeast and southeast corners.

Substantial loss of backfill thru toewall hole:

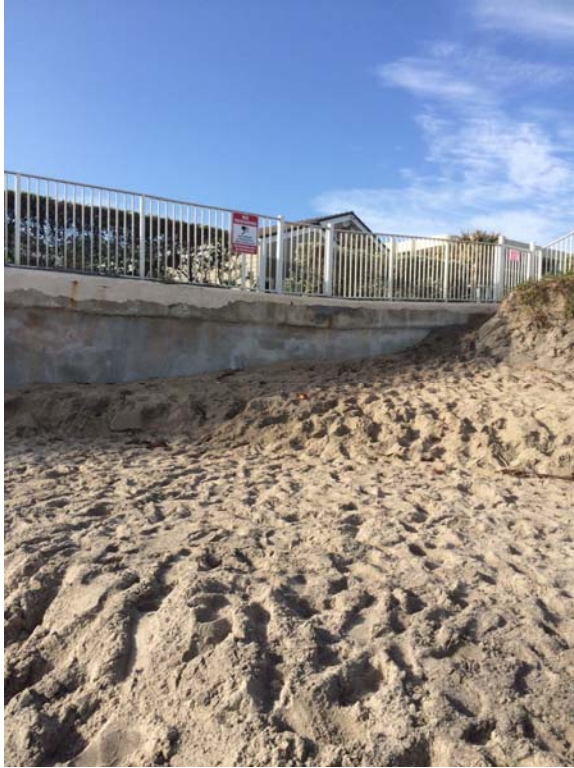
Western end of return, good condition:

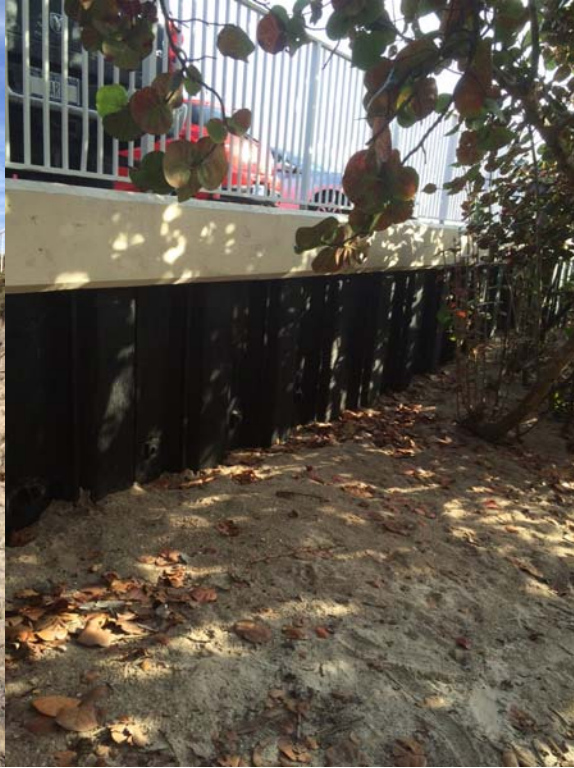
Parking lot seawall, good condition:
